Engineering Investigation of Ignition Failure Rate of TAU-15/B Infrared Target Flares

by Russell A. Bunn, Capt, USAF

APGC Technical Documentary Report No. APGC-TDR-63-27

MAY 1963 • APGC Project No. 7826W28

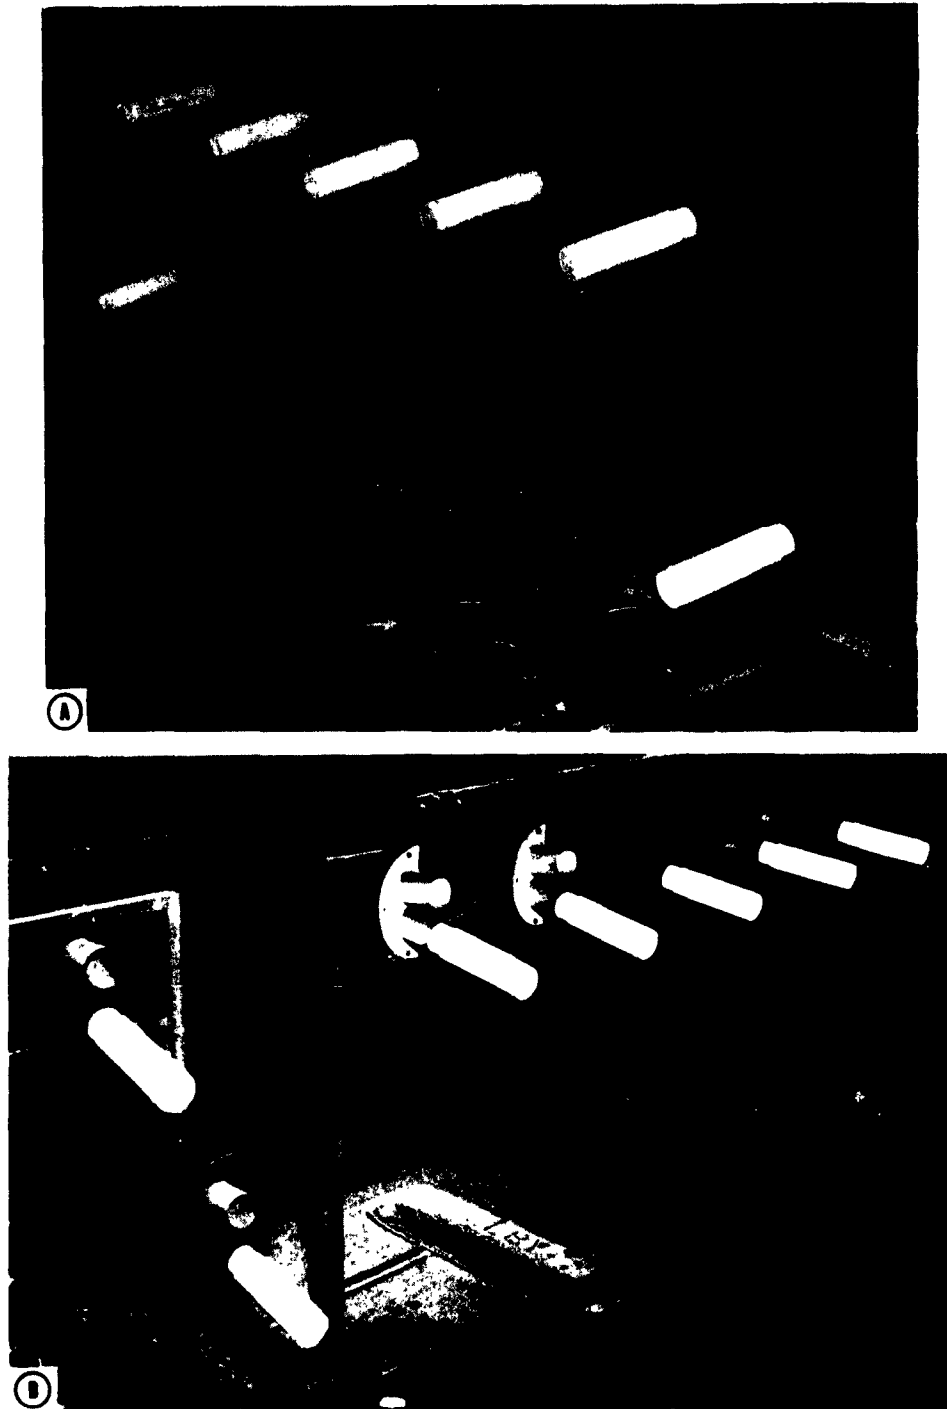
Fig. 4: Modified Flare Test Rack Arrangement: (A) Modified Rack, (B) Right End of Modified Rack and Adjacent New Rack.

The explosions were always very forceful and generally disrupted testing procedures by damaging the test setup in the altitude chamber. Spring-loaded contact points in the flare-holder sockets were often broken off by the shock. The base plates of two flare holders (Fig. 4) were bent beyond further use. The shock sometimes broke the welds holding the racks in an upright position and knocked the racks over. Illuminant burning on the chamber floor burned the ignition wiring and delayed testing while repairs were made.
